REPORT NUMBER: FHWA-AZ-8802 & FHWA-AZ-8803

SENTRAL AND TREND ATTENUATING SYSTEMS

Final Report

July 1991

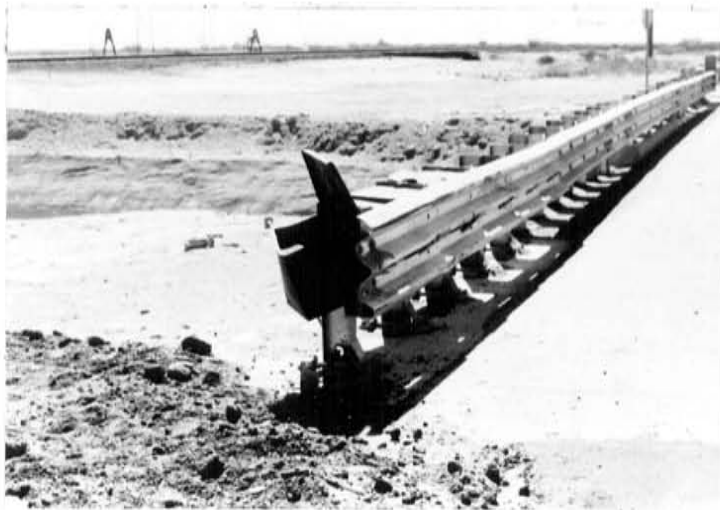
The first SENTRE impact damage was on the northwest attenuator and discovered on August 22, 1989. There were no witnesses to the impact and no accident report was filed. During that period of time a Maricopa County road construction project was underway in the immediate vicinity and US 60 was temporarily realigned just west of the attenuators. Because of the construction, there was considerable heavy equipment and semi-truck traffic. There were black tire marks on the top and bottom of the damaged attenuator suggesting that the impacting vehicle may have been one of these large construction vehicles. Because of the extent of the damage, it was uncertain if the attenuator would perform as designed upon a subsequent impact, and the damaged attenuator was repaired. A photograph of the damaged attenuator is shown in Figure 20.

Figure 20 Damaged SENTRE Attenuator.

The thrie beam fender panel was also damaged by this first impact, suffering a slight crimp. Because of the minor amount of damaged sustained, and the substantial cost of replacement (\$227), it was decided that the crimp would be pounded out, as opposed to replacing the panel.

An itemized list of the replaced components and associated costs is shown in Table 1. The unit prices are those provided by EASI at the time of replacement.

According to the work report filed by District 3 Maintenance Division, the actual repair process was simple and was carried out by three men working a total of eight hours each. The total cost of the repair including parts, labor, shipping and tax came to \$606.

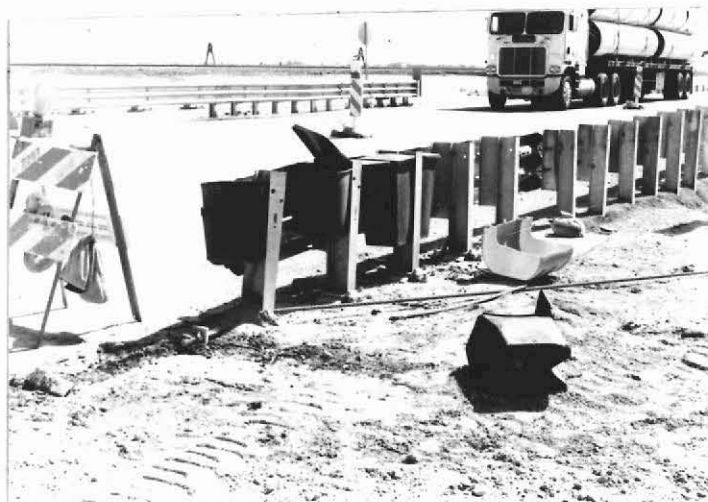
The second impact was discovered September 26, 1989. The Maricopa county road construction project was still in progress on US 60, and the highway was still temporarily realigned beginning just west of the SENTRE attenuators. As with the first incident, there was a significant amount of heavy construction equipment and semi-truck traffic. Two of the attenuators were discovered to be damaged; the southwest more severely than the northwest. At the southwest attenuator, marks in the soil and impact induced spalling of the SENTRE's concrete footing served as evidence that a front end loader or scraper had scraped its bucket or blade all the way up to the attenuator. The southwest attenuator was obviously impacted by a large construction vehicle, possibly the same vehicle that had left the scrape marks in the soil. This

attenuator was impacted in the direction of travel and telescoping of the panels did occur. The mushroom bolt attached to panel 1 was free to slide as designed. A photograph of the damaged system is included as Figure 21.

Figure 21 Damaged Southwest SENTRE Attenuator.

The northwest attenuator was hit on the nose longitudinally. Post 1 was slightly twisted but judged operational. An itemized list of the items replaced and associated 1989 costs is given in Table 2.

Again the repair was simple. A three-man maintenance crew worked a combined total of 24 man-hours to complete the repair. The total cost to ADOT including parts, labor, shipping, and tax came to \$600.

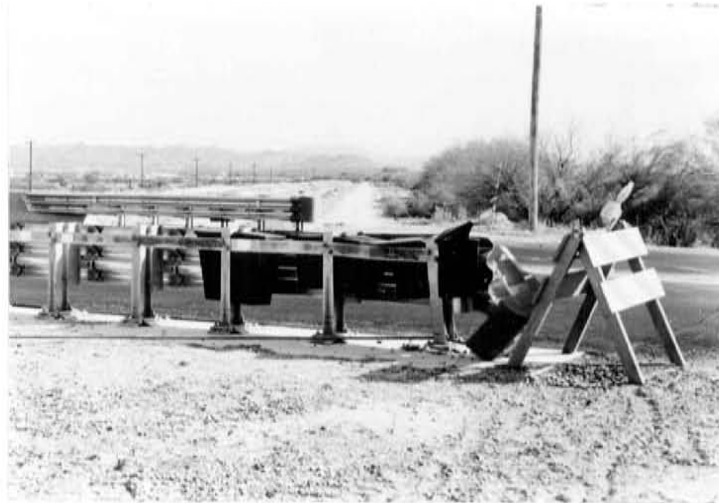
The vehicle damage to the TREND system was discovered on January 30, 1989. There were no witnesses to the impact. The southwest attenuator was hit from the side, suggesting the vehicle was intent on travelling west on the dirt access road along the canal. Photographs of the damaged TREND system are included as Figures 22 and 23.

Figure 22 Damaged TREND Attenuator.

The damaged TREND system was no longer parallel with the roadway, and it's future performance was doubtful. As such, Energy Absorption Systems, Inc. was contacted for replacement parts and the system was repaired. Table 3 shows an itemized list of components replaced and associated costs from EASI at the time of replacement.

The thrie beam fender panel was also slightly dented. The minor amount of damage sustained combined with the substantial replacement cost (\$227) resulted in a decision not to replace the component.

The repair was performed by an ADOT maintenance crew. The crew dismantled and removed the damaged components, and replaced them with the new parts. The crew of three men worked 4 hours, for a total of 12 man-hours, to complete the job. The labor cost was \$113, bringing the total cost of repair including parts, labor, tax, and shipping to \$540.

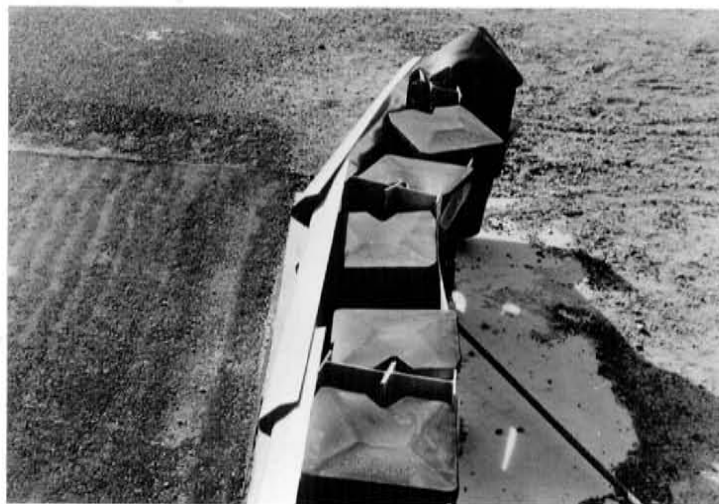
Figure 23 Damaged TREND Attenuator.

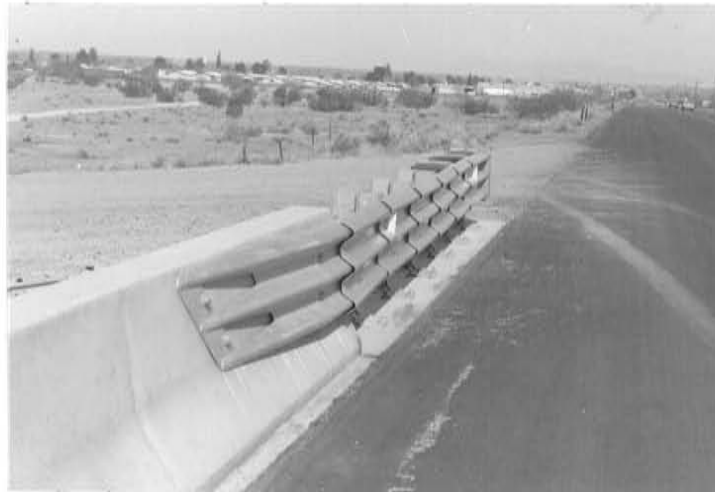
The initial construction of the SENTRE and TREND was performed without difficulty. A major concern expressed by ADOT District 1, District 2, District 3, and Highway Plans is the overlapping of downstream thrie beam panels. The panels are overlapped such that telescoping will occur upon a head-on impact. Longitudinal impacts are the source of concern. On the upstream installation of the SENTRE and TREND systems, the overlapping panels do not pose a problem. However, on the downstream installation the overlaps leave exposed edge sections. The concern lies with a vehicle snagging on these overhanging panels during the course of a longitudinal hit, encountering a more hazardous situation than a similar impact with the panels overlapping away from traffic. An illustration of the panel overlapping is presented as Figure 24. The upstream panels are illustrated in Figure 25.

Figure 24 Overlapping Panels on Downstream Attenuator.

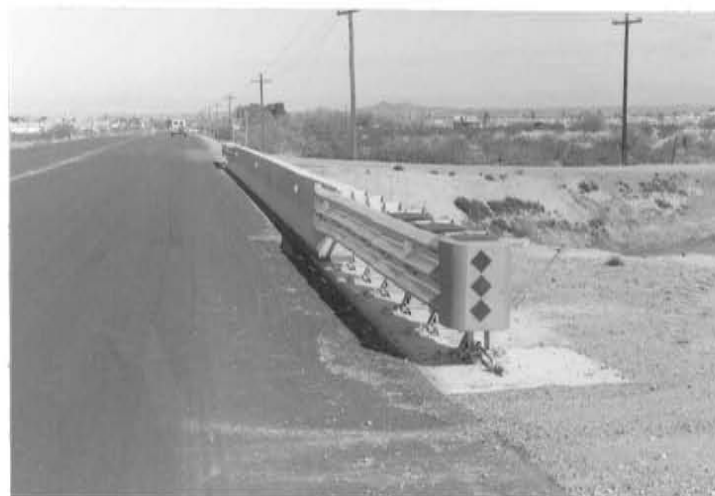
Figure 25 Overlapping Panels on Upstream Attenuator.
